## Long term outdoor exposure in different climate zones

# German joint project ‚PV reliability‘ Project description

Study of outdoor weathering effects is part of a German research project focussing on “PV reliability” (2005 – 2009 – 2013)

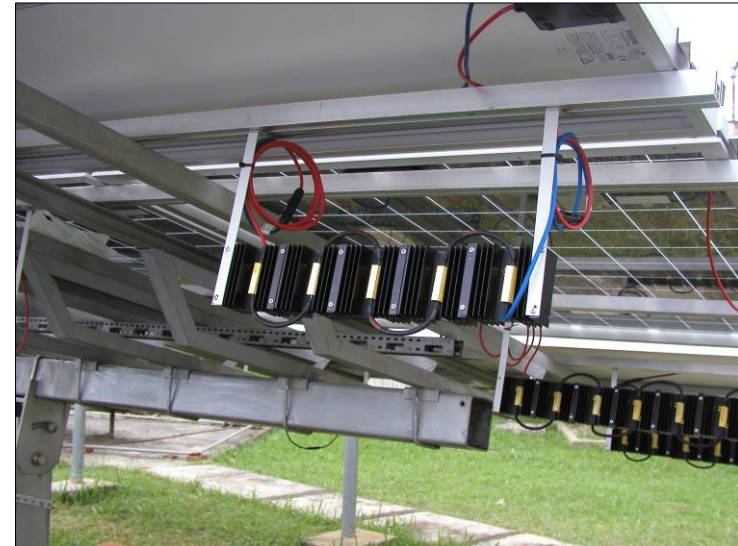
**Installation of 3 test samples of  
7 module types at any test location:**

- approx. 30 m<sup>2</sup> installed module area
- Operation via resistive load

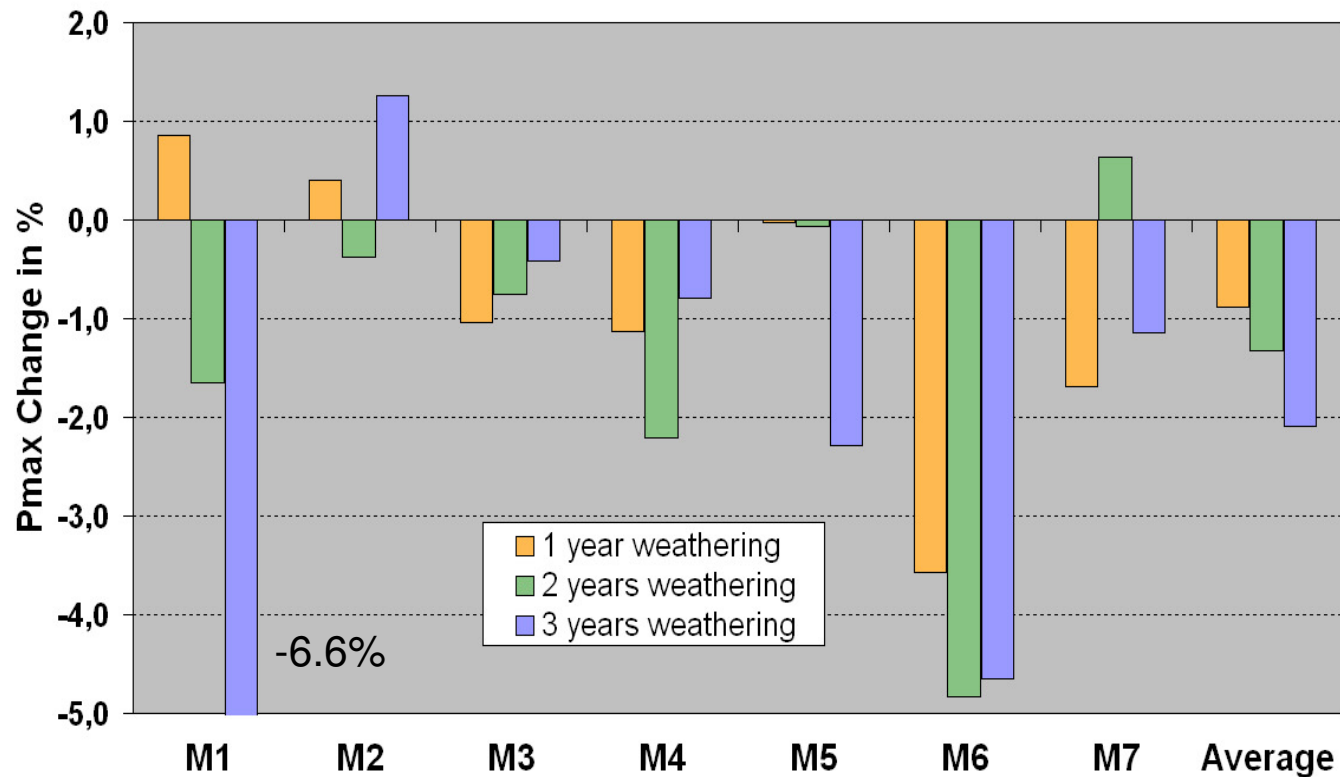
delta Pmax at Zugspitze

- largest degradation found for all locations
- up to -6.6% power loss
- major defects caused by cell breakage

- power loss up to -3.3 % due to soiling at the tropical location (reversible)
- power loss up to -6.6 % due to cell breakage at the high mountain location caused by high snow and wind loads (low T => elastic modulus high, stress more easily leads to cell breakage)

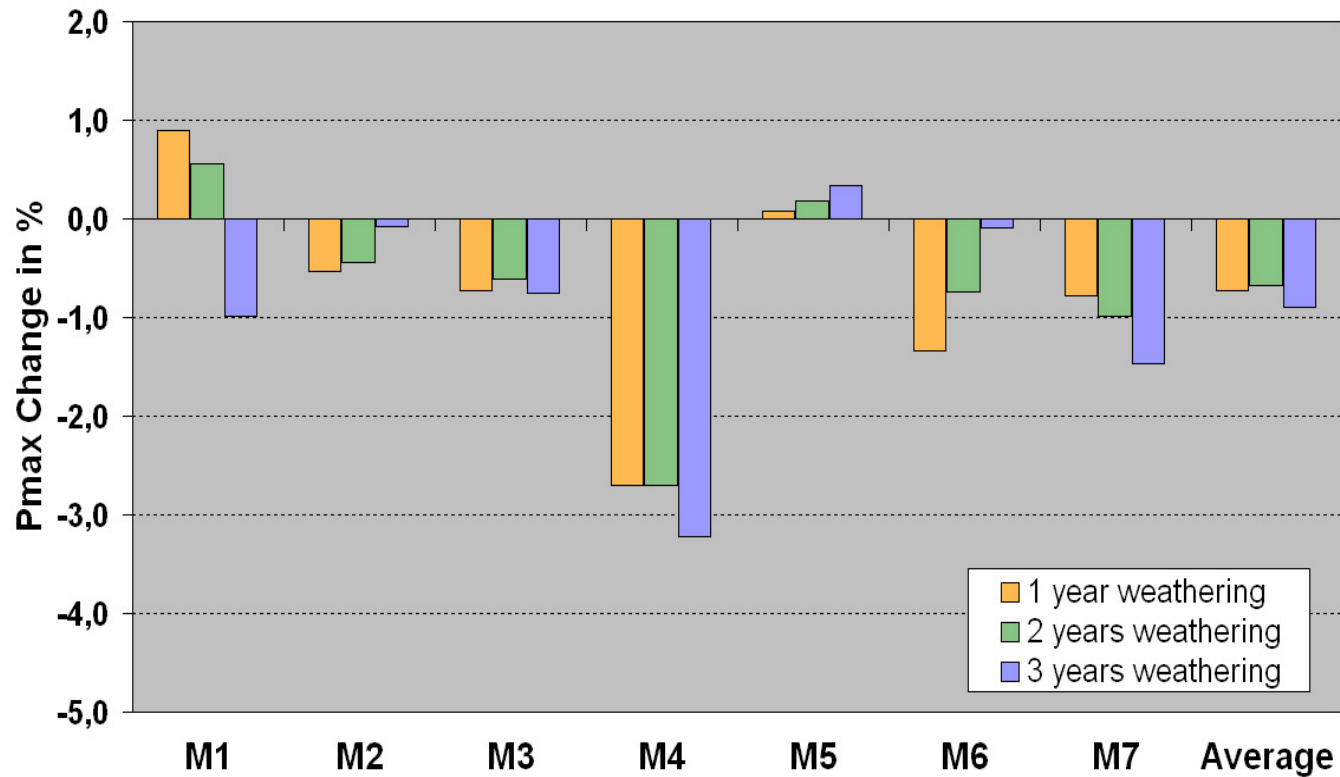
delta Pmax at Serpong

- Degradation for some modules slightly larger than measurement uncertainty
- M4 suffers from solarization of glass

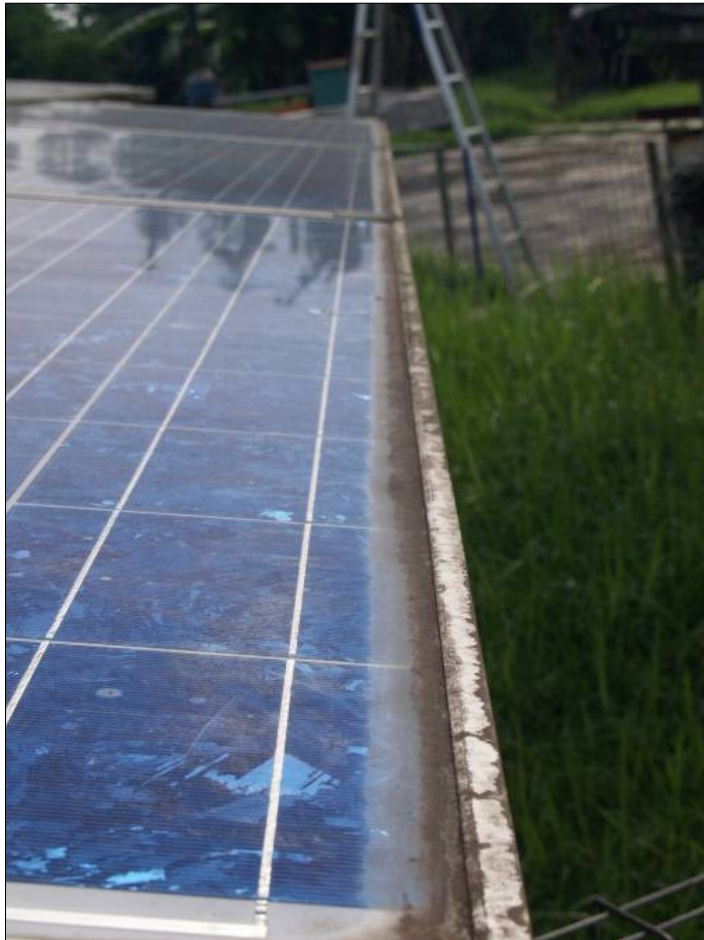
# Outdoor exposure visual changes

- power loss up to -3.3% due to soiling at the tropical location (reversible)

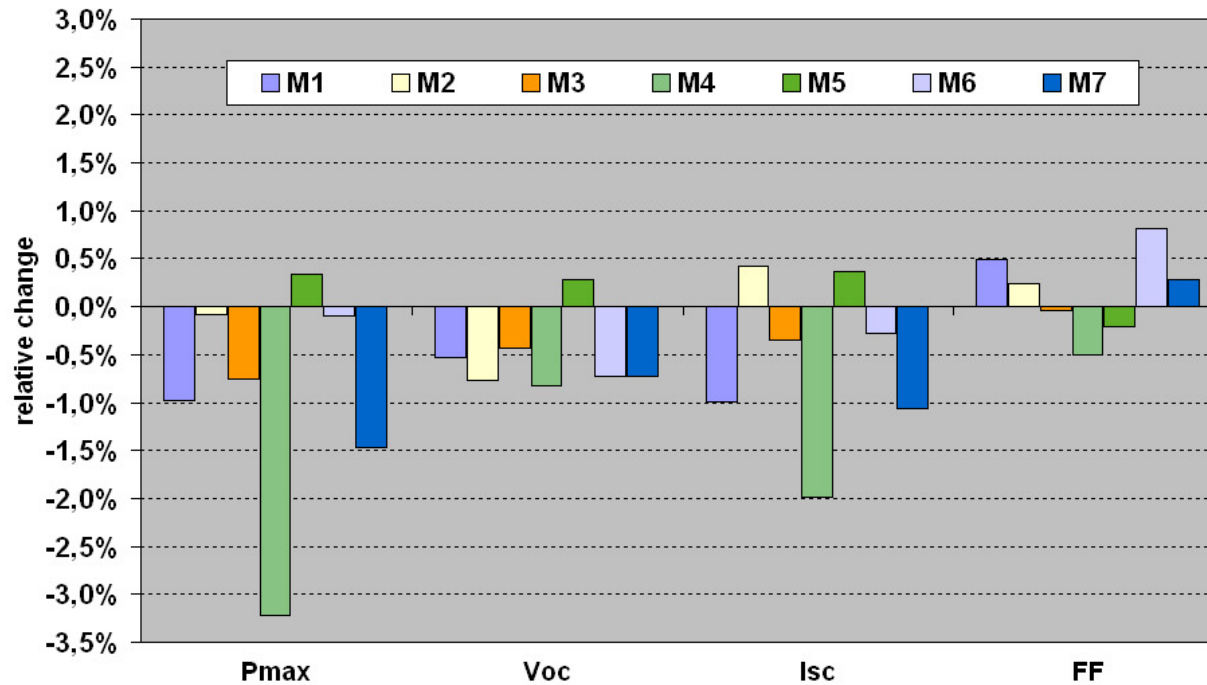
3 years at Serpong

- different degradation mechanisms impact on different module parameters
- solarization, transmission loss and soiling =>  $I_{sc}$   
cell corrosion, contact corrosion and busbar degradation => FF ( $R_s$ )
