UV-Thermal Combined Stress Acceleration Test

Takuya DOI

RCPVT / AIST, Tosu, Japan

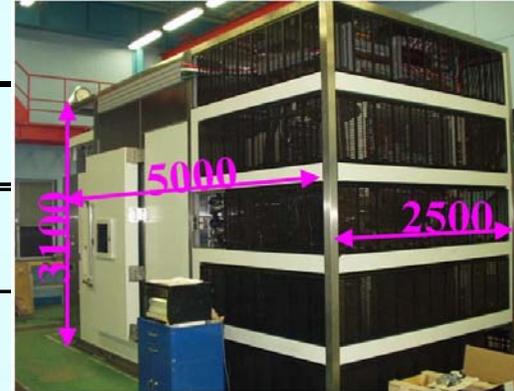
Experimental apparatus

Specifications

item	spec
temperature control (w/ o irradiation)	- 40 ~ +90 °C
temperature control (w/ irradiation under 3UV)	+50 ~ +90 °C
humidity control (w/ o irradiation over room temp.)	(max) RH 85± 5%
maximum irradiance	3 UV
temporal instability of irradiance	under 10%
non- uniformity of irradiance in the test plane	under 15%
maximum sample size	1218H x 445W
sample capacity	3 panels

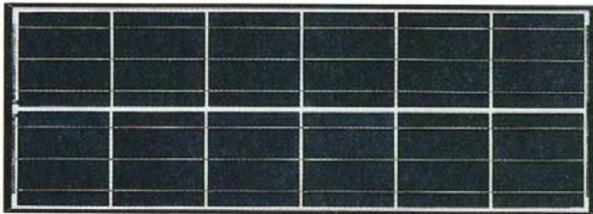
Model	xxxx
Nominal maximum output	45W
Nominal open circuit voltage	6.0V
Nominal short circuit current	7.50A
Nominal maximum output voltage	7.4V
Nominal maximum output current	8.28A
Dimension	W972 x L 345 x H8
Weight	3.7 kg

Module A (multi-crystalline 156mm x 156mm 12 cells, 972H × 345W)

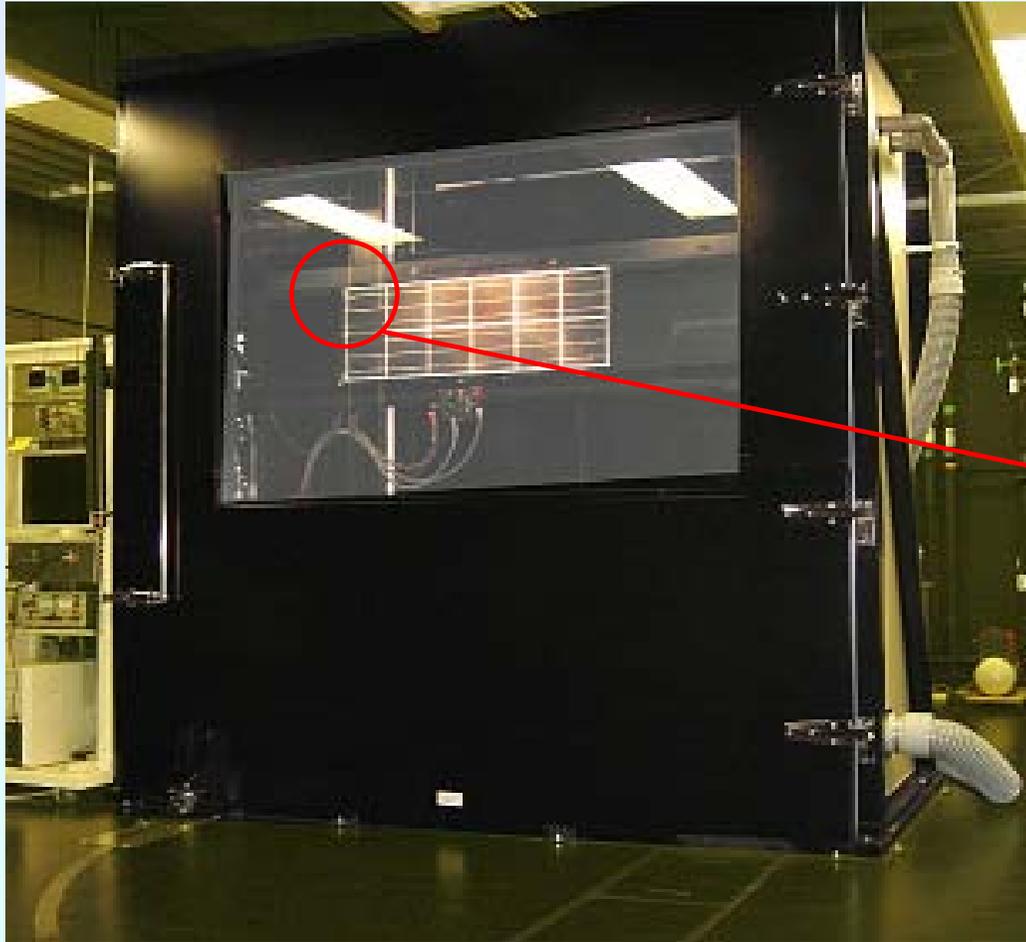
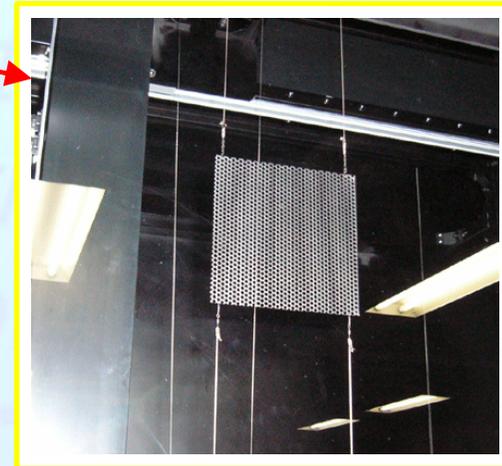
Isolation of IV curve

Dimmer board with xy moving mechanical was equipped in the thermostatic chamber to obtain single cell's IV curve from the module IV curve.

Evaluate ΔI_{sc} of each cell as degradation index

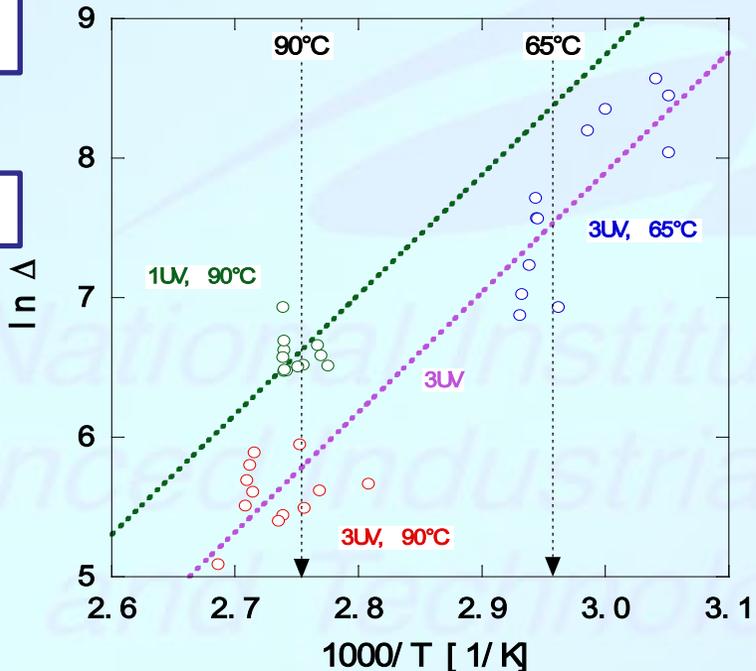
Module A

activation energy

$E_a = 0.75 \pm 0.05$ eV

factor for irradiation

$n = 0.75 \pm 0.15$

acceleration ratio

45~150

- (1) As for the factor for irradiation, the difference between module A and B was small, but that for temperature, it was large.
- (2) The acceleration ratio obtained from UV-thermal combined stress test was about 100. Degradation of window materials is not so large.
- (3) From TC.Irr test, it was shown that cell design such as finger electrode or J-Box affects on failures.

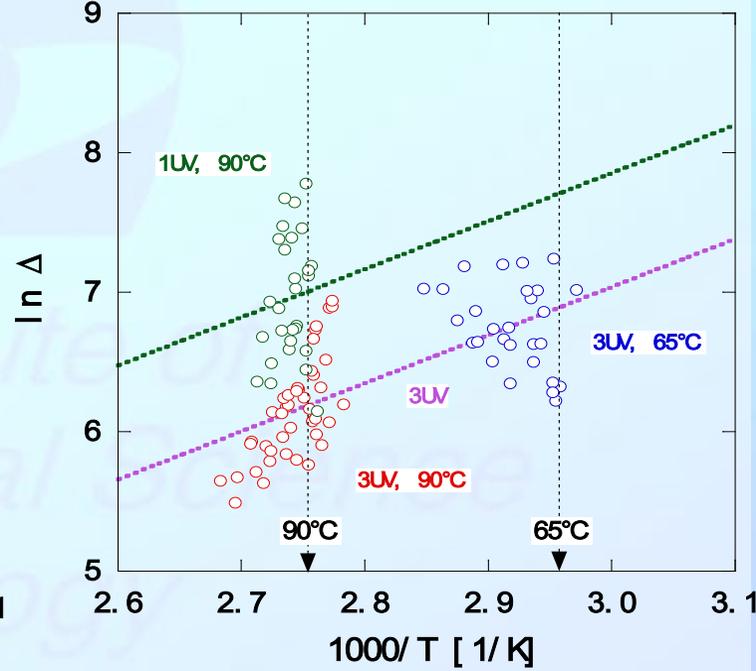
Module B

activation energy

$E_a = 0.30 \pm 0.05$ eV

factor for irradiation

$n = 0.75 \pm 0.15$

acceleration ratio

10~40

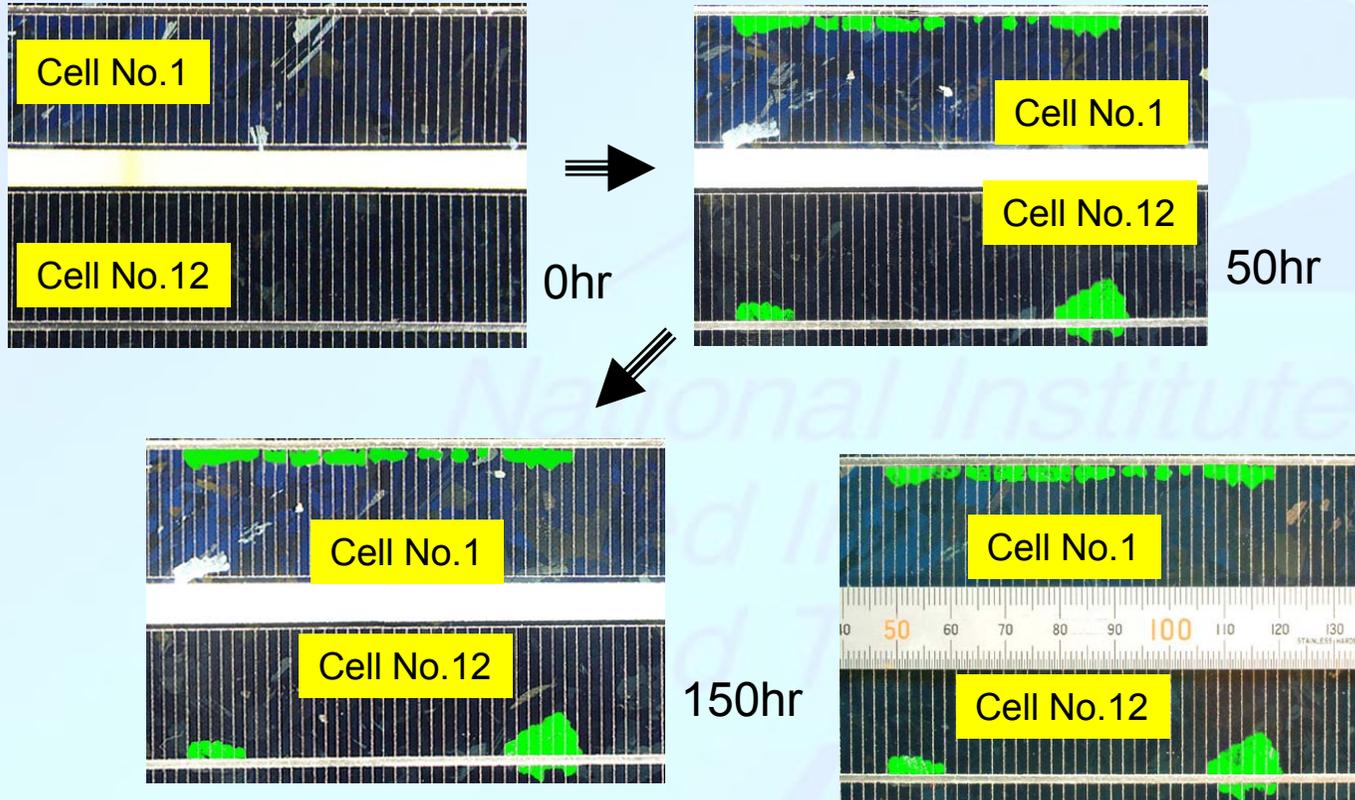
Module A-35 , Cell No. : 1 and 12 (output terminal : Open)

Delamination from TC w/ Irrad

Relative position - cell No. and J-Box:

■ indicates J-BOX viewed from the back sheet side of module.

Condition : 3UV, module temp. 75°C ~ 0UV, module temp. - 40°C, TC

Control test: TC w/o Irrad, delamination occurred
 ⇒ Delamination originates from thermal cycle

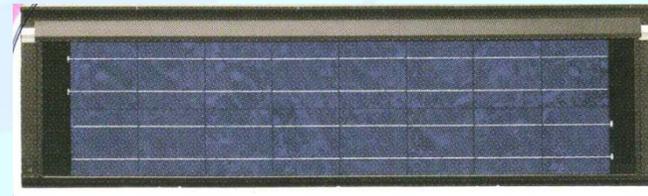
Module C

1209×330×34.9

$P_m=38W$, $V_{pm}=7.74V$, $I_{pm}=4.91A$,
 $V_{oc}=9.70V$, $I_{sc}=5.40A$

Failure: swells in back sheet appeared

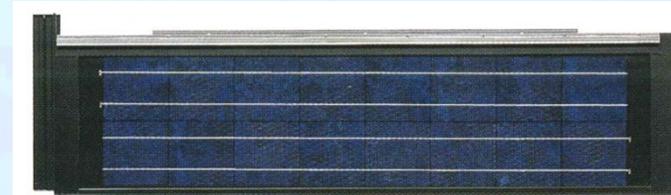
Module D

1228×280×29.7

$P_m=38W$, $V_{pm}=7.74V$, $I_{pm}=4.91A$,
 $V_{oc}=9.70V$, $I_{sc}=5.40A$

No Failure

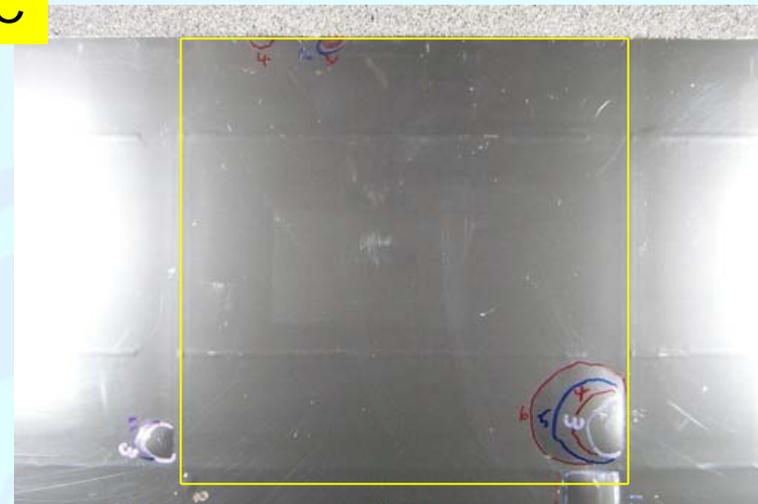
Cell No. 4

Swells in back sheet

test recipe	cumulative test hours	line No.
3UV, 90degC	230	1
3UV, TC 75degC ~ -20degC	280	2
	330	3
3UV, TC 75degC ~ -40degC	380	4
	480	5
	580	6

Pictures represent swells: Similar swells appeared in other cells in No. 5, 6, 7, 9, 10, 11, 12, 13, 14, 16.

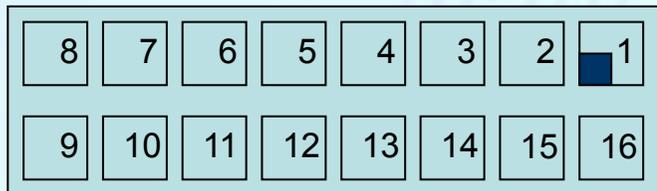
Relative position - cell No. and J-Box:

■ indicates J-BOX viewed from the back sheet side of module.

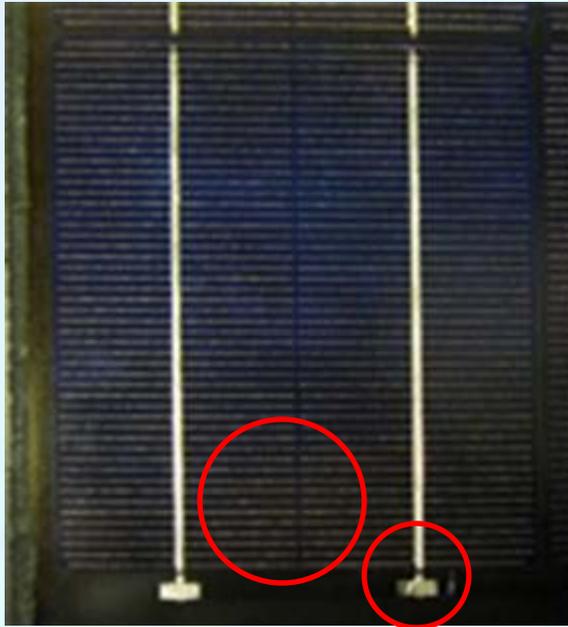
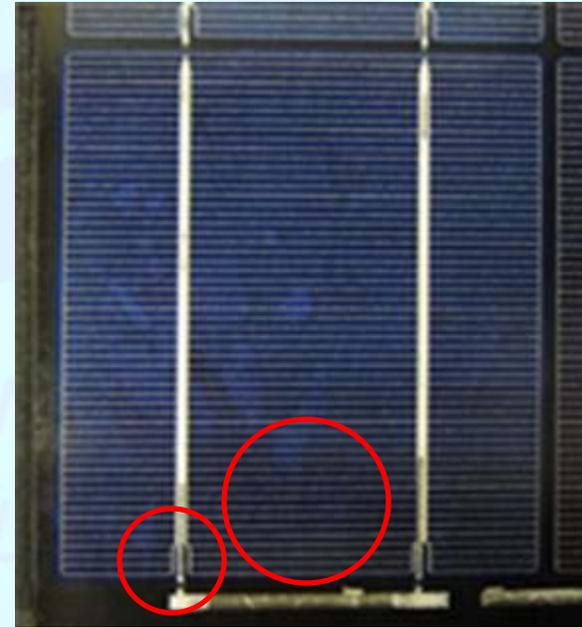
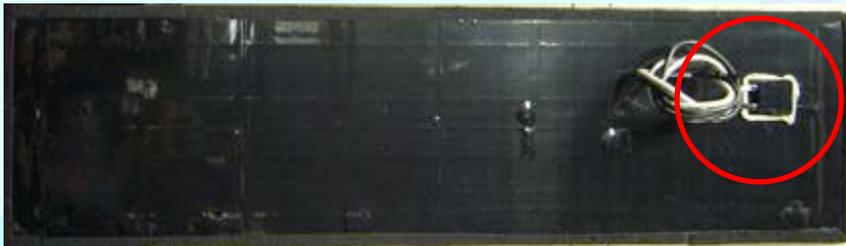
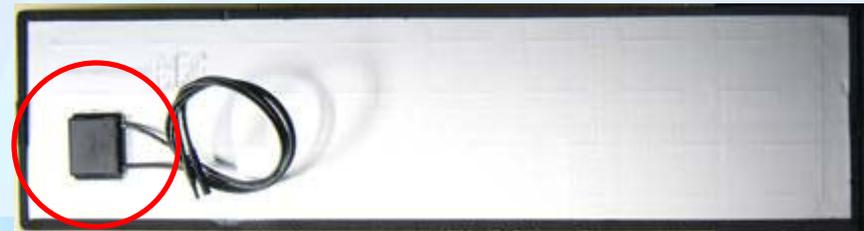
Improvement?

Finger electrodes: separated in center → continuous lines

J-BOX : small → large
